Manhole Inspection Summary

Manhole # S43K__037MH

Location Address: **631 alicenna st**

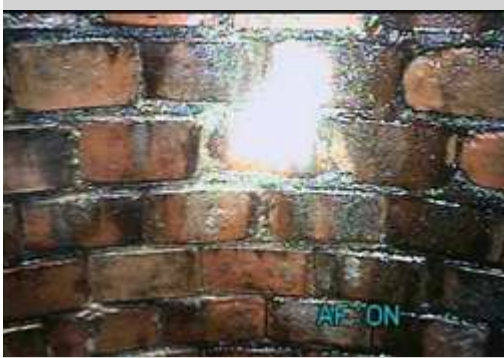
Defect 2

Infiltration: ☐ None ☐ Joint ☐ Cracks ☐ Mortar ☐ Roots ☒ **Wall**

infiltration barrel wall

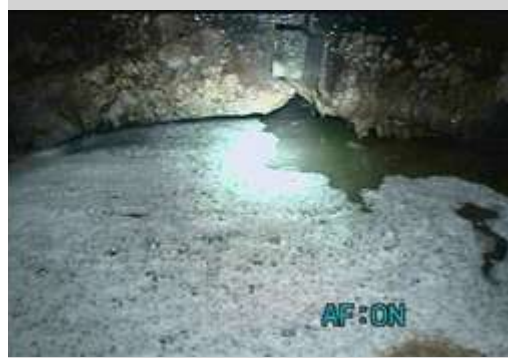
Defect 4

Condition: ☐ Sound ☐ Cracked ☐ Root Intrusion ☒ **Loose Brick** ☐ Deteriorated

barrel loose bricks

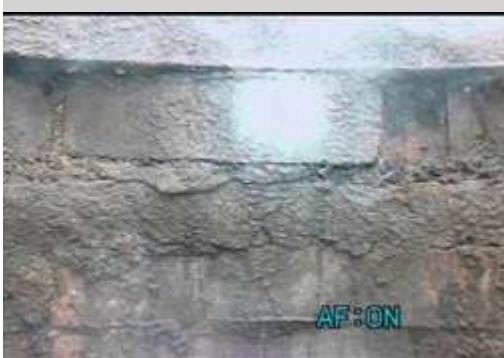
Defect 1

Offset: **2** (in.)

offset, adj

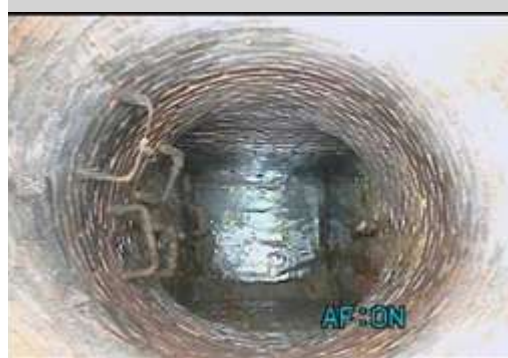
Defect 3

Count: **12** Missing: **4** ☒ **Corroded**

☒ **Evidence Of Surcharge** Depth: **8** (ft.) ☐ Active Surcharge Present

steps missing/corroded, surcharge evidence

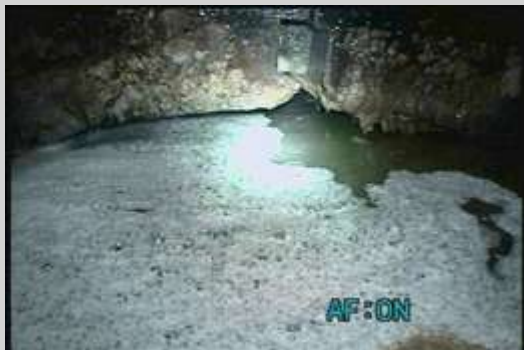
12 O'Clock Outflow

42 in. Circular Gravity Sewer
Pipe Out @ 12 O'Clock

Infiltration: **None** Pipe Seal Cond: **Unknown**

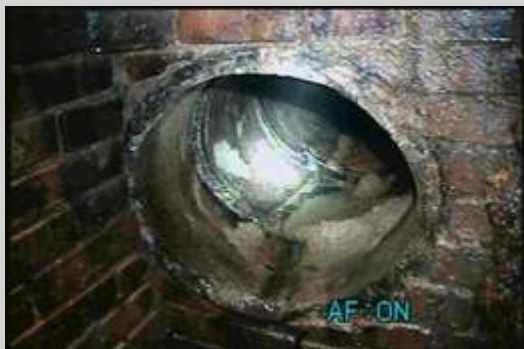
3 O'Clock Inflow

15 in. Circular Gravity Sewer
Pipe In @ 3 O'Clock

Infiltration: **None** Pipe Seal Cond: **Unknown**

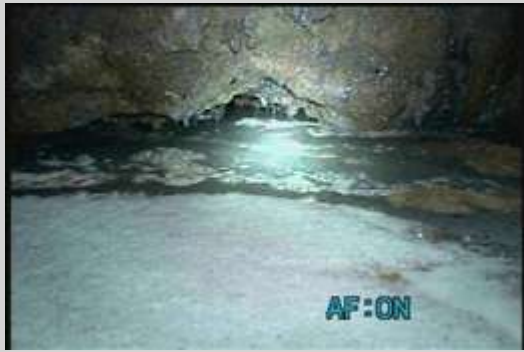
6 O'Clock Inflow

42 in. Circular Gravity Sewer
Pipe In @ 6 O'Clock

Infiltration: **None** Pipe Seal Cond: **Unknown**
